**DEPARTMENT OF TRANSPORTATION****DIVISION OF ENGINEERING SERVICES**

Contract #: 04-0120F4Cty: SF/ALA Rte: 80 PM: 13.2/13.9File #: 1x.28**WELDING INSPECTION REPORT****Resident Engineer:** Casey, William**Address:** 333 Burma Road**City:** Oakland, CA 94607**Report No:** WIR-026565**Date Inspected:** 25-Oct-2011**Project Name:** SAS Superstructure**OSM Arrival Time:** 700**Prime Contractor:** American Bridge/Fluor Enterprises, a JV**OSM Departure Time:** 1530**Contractor:** American Bridge/Fluor Enterprises, a JV**Location:** Job Site**CWI Name:** Salvador Merino**CWI Present:** Yes No**Inspected CWI report:** Yes No N/A**Rod Oven in Use:** Yes No N/A**Electrode to specification:** Yes No N/A**Weld Procedures Followed:** Yes No N/A**Qualified Welders:** Yes No N/A**Verified Joint Fit-up:** Yes No N/A**Approved Drawings:** Yes No N/A**Approved WPS:** Yes No N/A**Delayed / Cancelled:** Yes No N/A**Bridge No:** 34-0006**Component:** SAS OBG**Summary of Items Observed:**

This Quality Assurance Inspector (QAI) was present at the SAS OBG segment 14W located at Pier 7. The following items were observed.

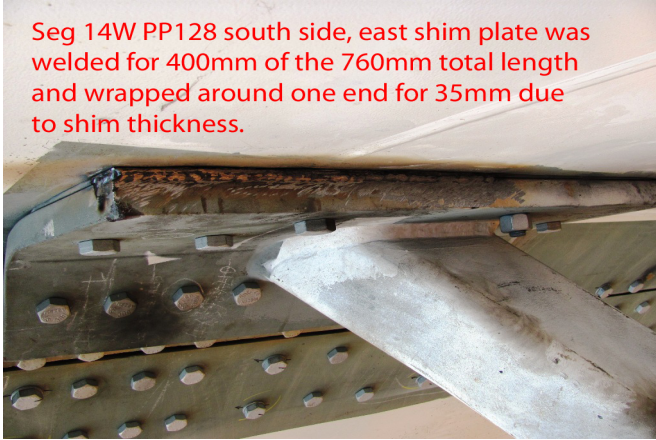
The QAI periodically observed AB/F approved welder Kevin Kananen assisted by Gilbert Perlata welding Assembly SA8507A shim plates to bent plate X8526A utilizing the Shielded Metal Arc Welding (SMAW) process in the 2G (horizontal) position with AWS E-7018 filler metal per ABF – WPS - D15 – 1081 rev 1. AB/F QC Inspector Salvador Merino was present to monitor the progress and verify that the welding parameters were within the limits established by the approved WPS. The west shim plate was welded per RFI 2602R0 and the east shim

plate was welded for 400mm of the 760mm total length and wrapped around one end for 35mm. This change in weld length was brought to the attention of Structural Materials Representative Bahjat Dagher.

Seg 14W PP128 south side, east shim plate was welded for 400mm of the 760mm total length and wrapped around one end for 35mm due to shim thickness.

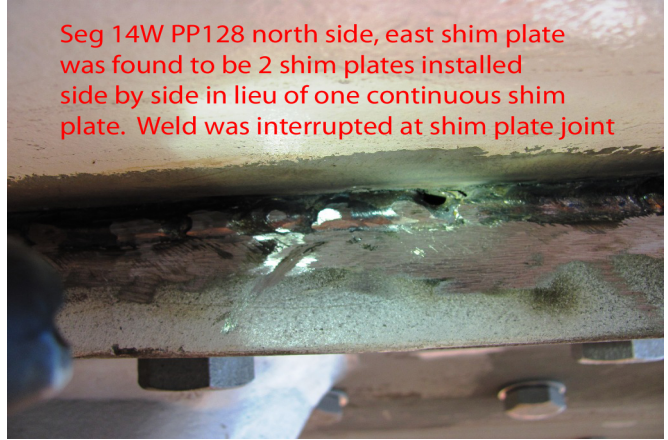
The QAI periodically observed AB/F approved welder Kevin Kananen assisted by Gilbert Perlata welding Assembly SA8508A shim plates to bent plate X8528A utilizing the Shielded Metal Arc Welding (SMAW) process in the 2G (horizontal) position with AWS E-7018 filler metal per ABF – WPS - D15 – 1081 rev 1. AB/F QC Inspector Salvador Merino was present to monitor the progress and verify that the welding parameters were within the limits established by the approved WPS. The west shim plate was welded per RFI 2602R0 and the east shim plate was found to be 2 shim plates installed side by side in lieu of one continuous shim plate. The weld was interrupted at the end of each shim plate. See attached picture. This change in shim plate length was brought to the attention of Structural Materials Representative Bahjat Dagher.

Seg 14W PP128 north side, east shim plate was found to be 2 shim plates installed side by side in lieu of one continuous shim plate. Weld was interrupted at shim plate joint

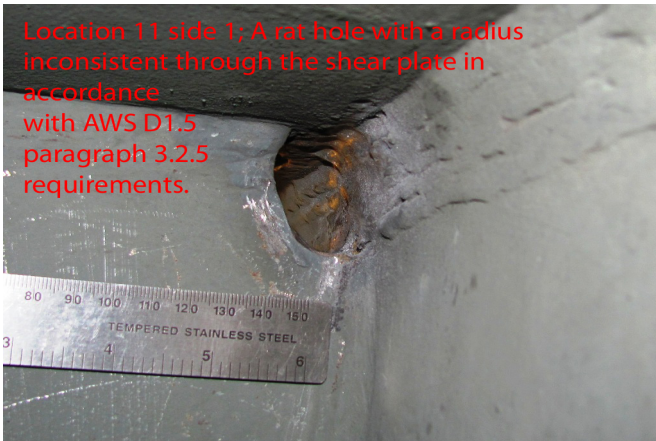
Location 11; Hole has penetrated into an existing weld access hole on the shear plate. A rat hole with a radius that is not consistent through the shear plate in accordance with AWS D1.5 paragraph 3.2.5 requirements. Bolt has not been installed.

Location 11 side 1; A rat hole with a radius inconsistent through the shear plate in accordance with AWS D1.5 paragraph 3.2.5 requirements.

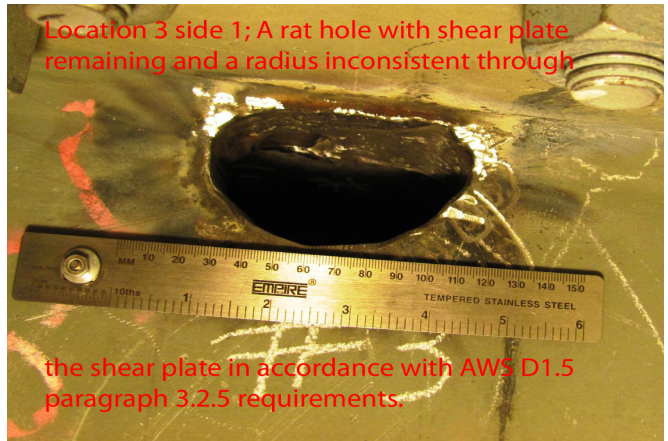
Location 3; Hole has penetrated into an existing weld access hole on the shear plate but part of shear plate remains. The rat hole has a radius that is not consistent through the shear plate in accordance with AWS D1.5 paragraph 3.2.5 requirements. Bolt has not been installed.

Location 3 side 1; A rat hole with shear plate remaining and a radius inconsistent through

the shear plate in accordance with AWS D1.5 paragraph 3.2.5 requirements.

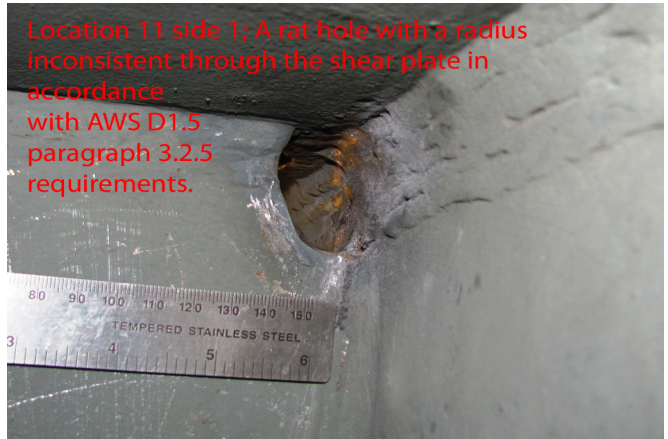
Location 11 side 1; A rat hole with a radius inconsistent through the shear plate in accordance with AWS D1.5 paragraph 3.2.5 requirements.
